# ASBESTOS-CONTAINING MATERIALS SURVEY

Proposed Chipotle  
16509 Fishhawk Blvd.  
Lithia, Florida  
UES Project No. 0741.2400073

Report Issuance Date: January 28, 2025

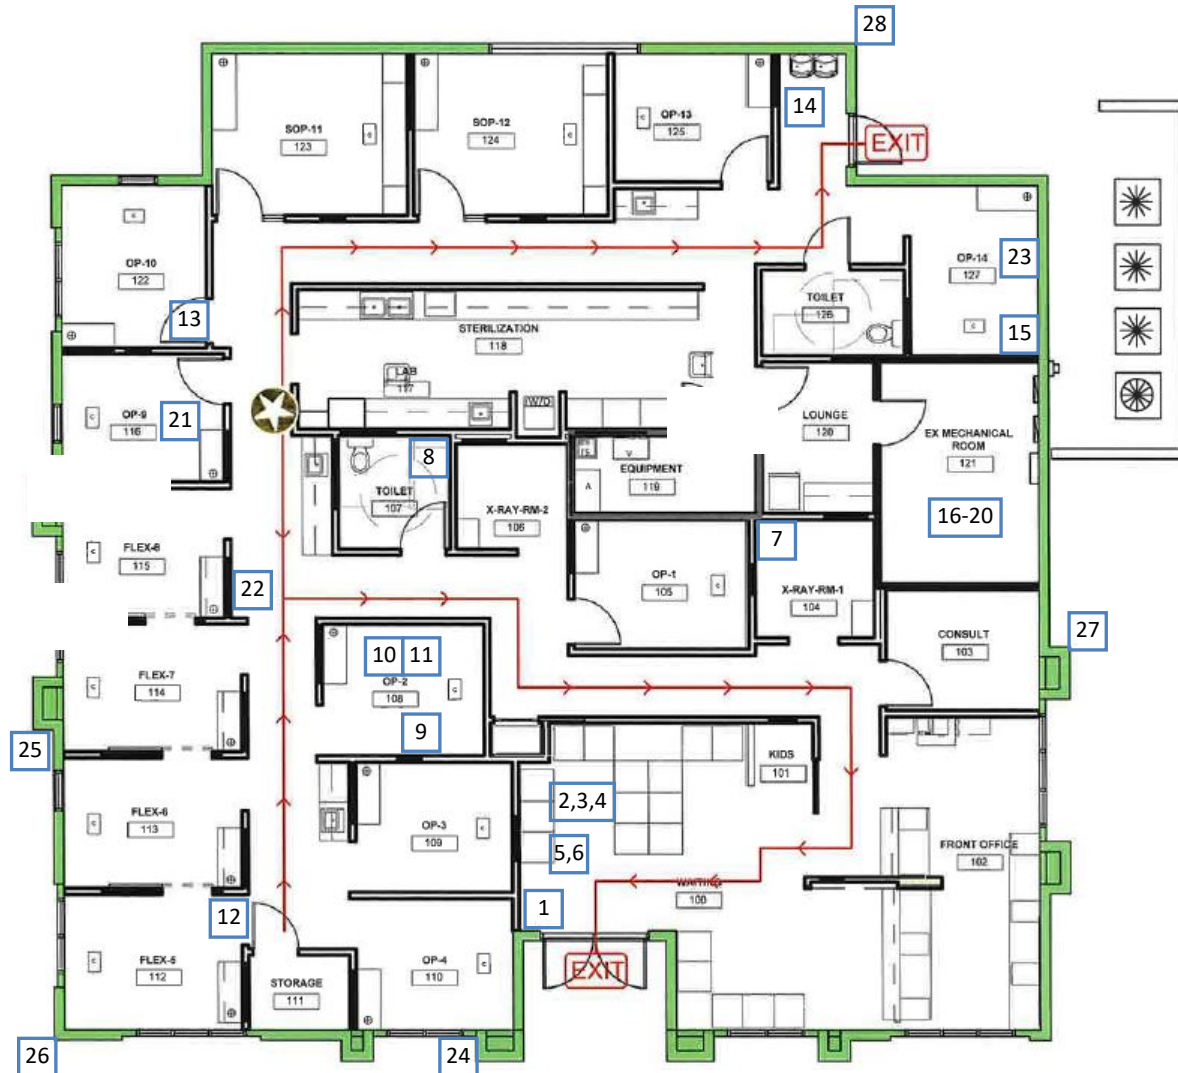
# APPENDIX A

Based on UES' review of the available building system information and visual survey of the subject building, 15 homogeneous materials were identified at the subject building commonly suspected of containing asbestos. The homogeneous materials consisted of drywall, joint compound, floor tile, ceiling tile, duct insulation, mastics and roof shingle. A map illustrating the sample locations is included in **Appendix A** of this report.
